**DELAWARE TOWNSHIP**

**CAPITAL IMPROVEMENT PLAN**

Project No. 1228004

October 2013

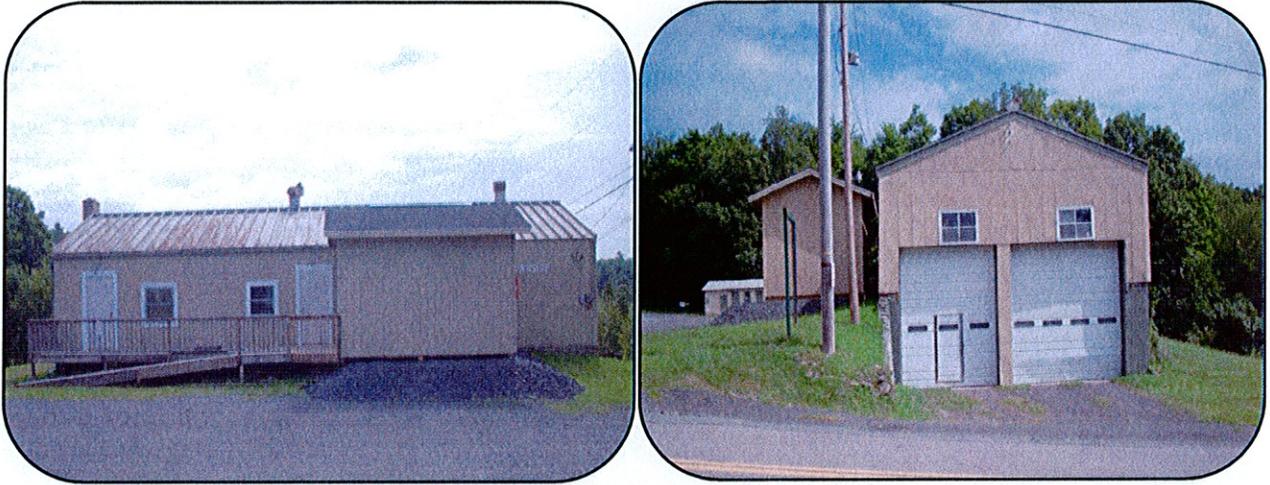
## DELAWARE TOWNSHIP EMERGENCY MANAGEMENT BUILDING

The Emergency Management Building is a one-story building with a walkout/drive out basement area. The basement is totally below grade except for the area where the upward acting doors are located.

1. Move the shed adjacent to the building. Its proximity is causing rainwater to flow down along the foundation of the building. Cost - \$0.00.
2. Provide the building with gutters and downspouts. The estimated cost is \$3,000.00.
3. Provide additional earth against the foundation on downhill side to help channel rainwater and runoff away from the foundation. This could be done by Township forces when fill becomes available from other projects. The estimate cost to fill, grade and seed is \$2,000.00.
4. There is one large crack in the foundation wall which could be cleaned and grouted, after rainwater is redirected, by moving the adjacent shed and installing gutters and downspouts. The estimated cost is \$1,000.00.

The ramp does not meet current ADA requirements. This could be upgraded for about \$5,000.00.

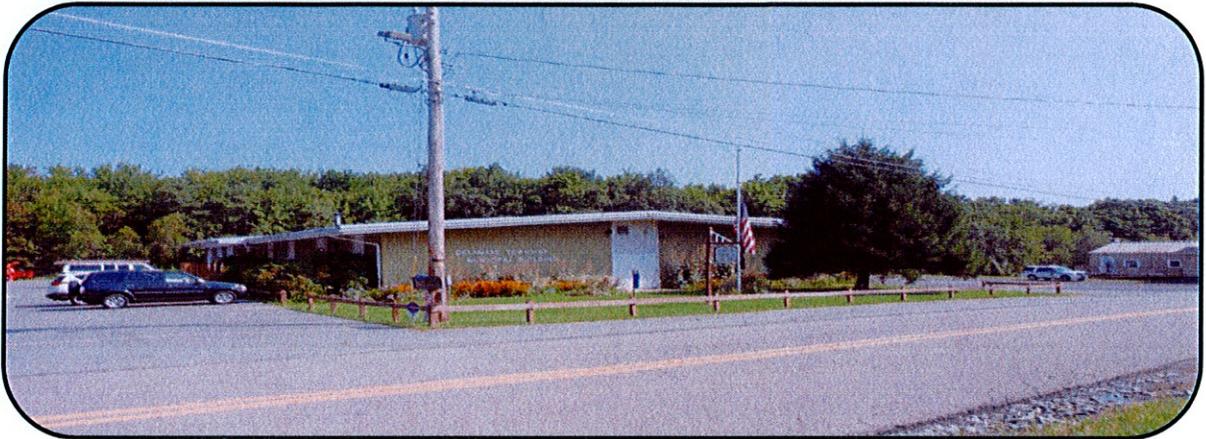
## DELAWARE TOWNSHIP MUNICIPAL BUILDING

1. The building is in relatively good condition. It is approximately 33 years old.
2. In the multi-purpose room, it appears that there has been some movement in the slab on grade and it's around the perimeter of the building. Something has happened to make the floor move and it is visible.
3. The roof over the office and multi-purpose room appears to be in good condition even though it was applied in 1985-1986.
4. The floor in the garage could use a grout topping.
5. It is our understanding that the boiler was replaced in the Spring of 2013 . It is our understanding that the heating in the community room office does not appear to be adequate in the Winter. However, additional insulation was placed above the ceiling in the Winter of 2012/Spring 2013. We recommend the situation be evaluated after the room is in use through the next winter season.

1. While not necessary, the floor in the garage could be topped with a grout to seal cracks and indentations from spalled concrete. Estimated cost \$7,000.00.
2. We do not recommend the uneven floor in the community room be repaired. The cost to repair versus the added utility does not seem to be beneficial in our mind. However, if the Township wishes to repair, we would recommend removal of the existing floor covering, blending the uneven surfaces with an application of grout and reapplying a floor covering. Estimated cost \$15,000.00-\$20,000.00.

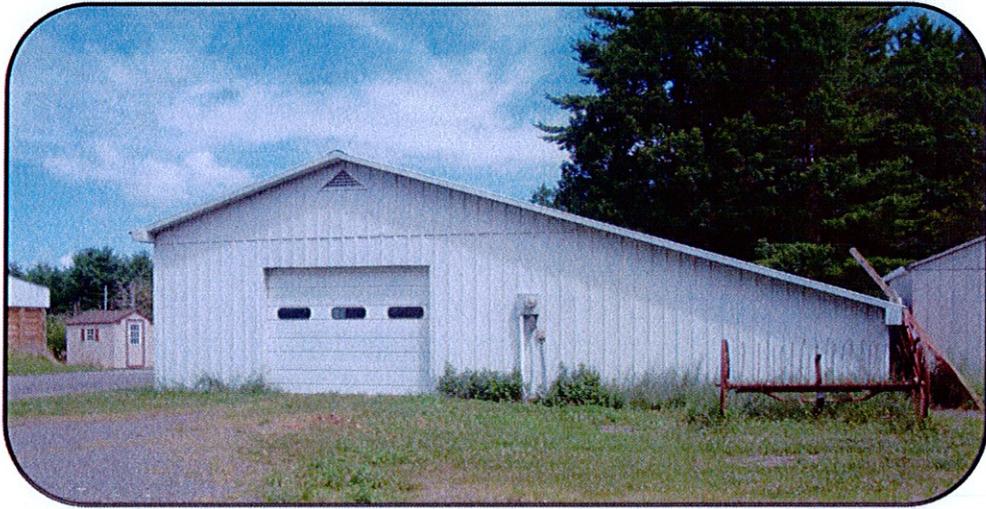
## DELAWARE TOWNSHIP RECYCLING CENTER

The Delaware Township Recycling Center is a one-story wood frame pole building.

1. Install emergency lighting. The estimate cost is \$2,000.00.

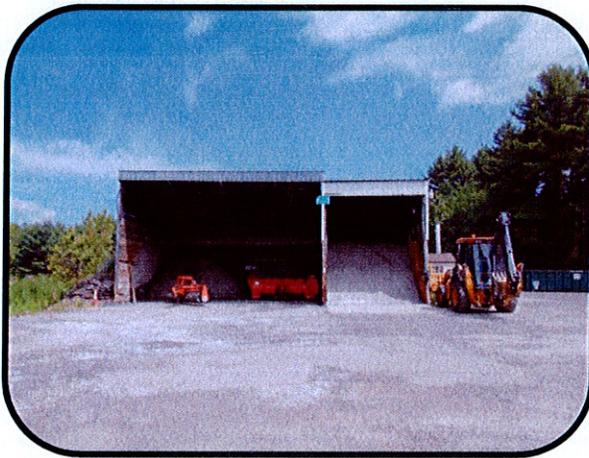
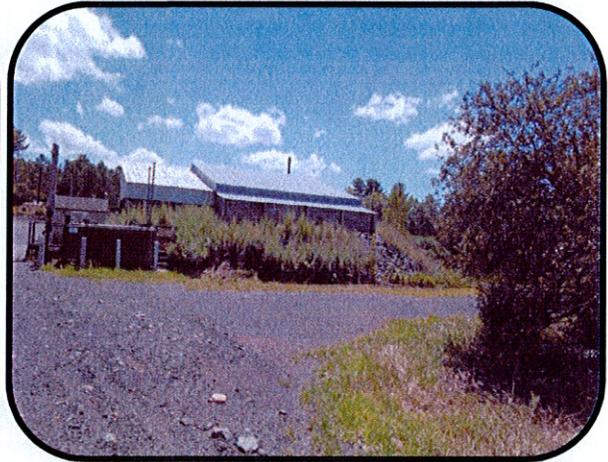
## DELAWARE TOWNSHIP SALT & CINDER SHED

1. The building appears as if it is 15-20 years old. In some places in the building, the metal is rusting. Because of the salt and caustic conditions caused by the salt, the fasteners should be reviewed to determine whether or not they are structurally sound. If not, the whole structure could have new fasteners that are designed for caustic conditions.
2. Most of the floor was not observable because of the cinders and ashes on it, but it may be in a state of deterioration.

1. Repairs. The fasteners in the entire structure should be examined, tightened and/or replaced, if failing. We estimate this could be performed for \$15,000-\$20,000.00.
2. The Township may wish to consider replacing the existing facility with a new salt shed constructed of corrosive resistive materials. We estimate this could be done for approximately \$80,000.00.

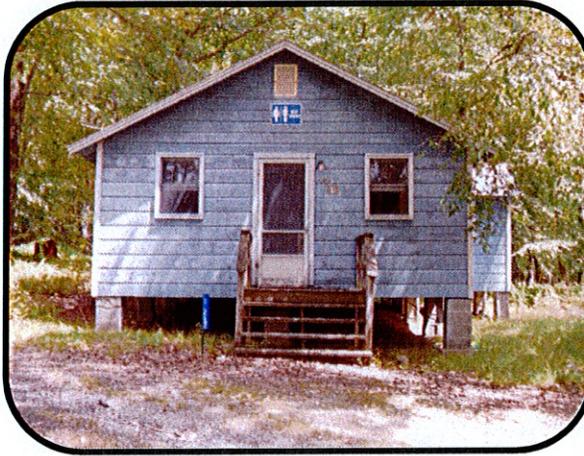
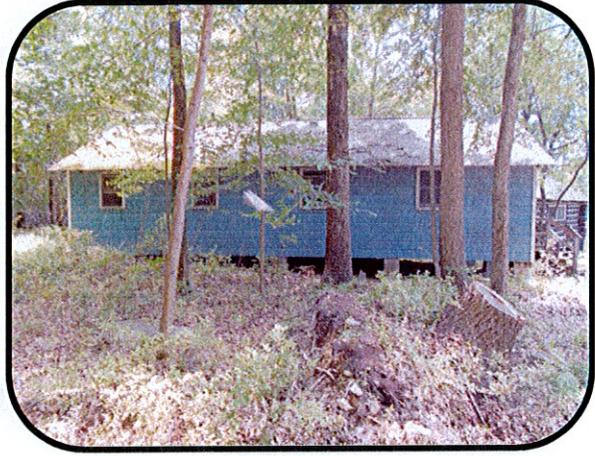
## AKENAC PARK BATH HOUSE/COMFORT STATION

1. The building is supported by a number of concrete masonry unit piers. These piers do not appear to be below the frost level and some of the piers are leaning, cracked and so forth. The piers should be temporarily stabilized until a decision is made pertaining to the structure.

1. All aspects of this building are in need of repair. Repairing one item, for example does not alleviate the need for a more or less immediate repair to the roof. This is further compounded by the fact that it is not ADA compliant. We estimate the cost to completely refurbish the building and making it ADA compliant to be \$110,000.00. Even with this estimate it is difficult to estimate an accurate cost for the foundation (pier) repair.
2. A new building, ADA compliant is estimated to cost \$190,000.00.

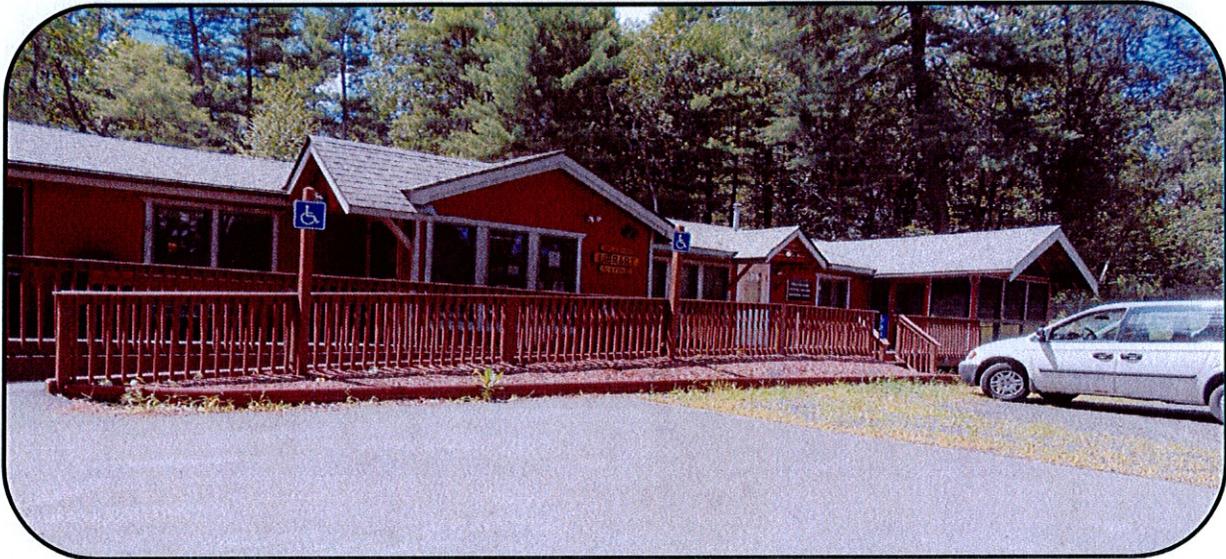
## DELAWARE TOWNSHIP LIBRARY/HISTORICAL SOCIETY

The Library/ Historical Society Building is a one-story building that houses the Library and Historical Society. It is a wood framed building constructed on a foundation of masonry piers and wood beams. The building is both heated and air conditioned. The building appears to be in good repair.

Other than typical building maintenance we see no need to recommend repairs or improvements to this building. Should the Township wish to bring the access ramp and doors into strict compliance with current ADA criteria we would estimate it could be done by township labor at a cost of approximately \$5,000.00. If done under prevailing wage guidelines our estimate would be \$7,000.00.

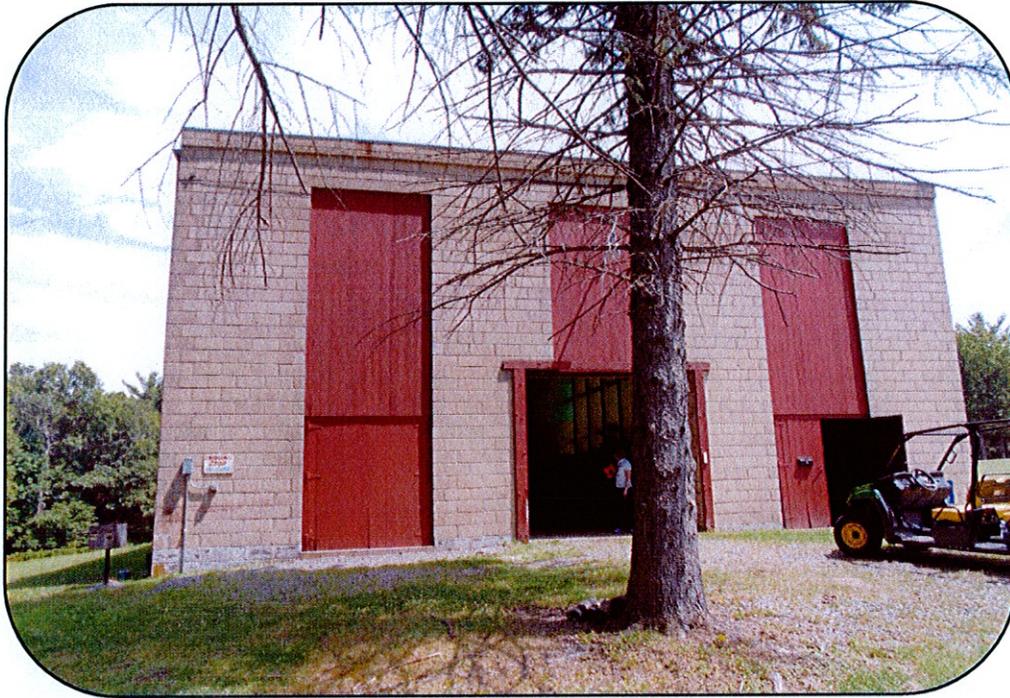
## **AKENAC PARK MAINTENANCE BUILDING**

1. There are some minor cracks in some of the concrete masonry unit walls.
2. There appears to be some rainwater damage on some of the exterior concrete masonry unit walls and these should be repaired.
3. The gutters and downspouts should be reviewed to determine if they are large enough to handle the rainwater.
4. The masonry portion of the building appears to need a cleaning and it probably never had a water repellent treatment.
5. The building now has two means of egress, but they are not reasonably remote. Another exit door should be placed in the building to make the exits reasonably remote.
6. There is electric in the building, but there isn't any emergency lighting or no exit signs in the building.
7. The current building code would require toilet rooms.
8. A new rubber roof membrane with celotex underlayment with twenty (20) year warranty was applied in summer of 2013.

1. Calculate size of new rain gutters and downspouts and install. The estimated cost is \$6,000.00.
2. Patch cracks in foundation and masonry units. The estimated costs is \$3,000.00 to \$5,000.00.

3. Apply waterproofing to masonry walls. The estimated cost is \$5,000.00.
4. Provide emergency lighting. The estimated cost is \$3,000.00.
5. Provide another access door. The estimate cost is \$5,000.00.

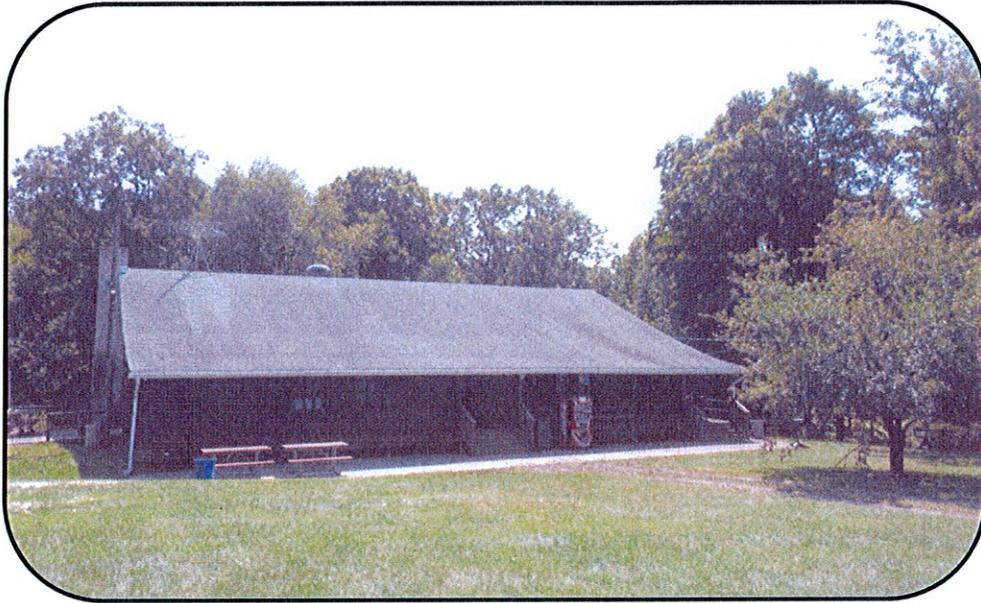
## AKENAC PARK RECREATION CENTER

1. There is a grid of piers that support the building and it is questionable whether the piers go down to frost level.
2. The beams that support the floor joists are questionable. The floor joists themselves are marginally adequate. They are 2 x 8's at 16" on center and they are spanning 10 feet.

3. The floor structure and supporting foundation of the building should be analyzed to determine whether it is adequate.
4. The walls appear to be 2x4 wood construction with wood siding on the exterior and wood paneling on the interior.

7. The building appears to need another means of egress. The remoteness of the doors does not meet Code. It's a recommendation that another door be placed near the rear of the building.

1. To maintain the building under any scenario will require repairs to the supporting piers. During our initial observations we were unable to determine if they have frost protection. Due to the shifting of some of the piers we believe they do not. However, after careful consideration it may not be feasible to provide frost protection due to the difficulty of working beneath the existing structure. With that understanding, all piers should be thoroughly checked for plumb and structural integrity. Repairs are estimated to cost \$25,000.00, although this estimate is subject to revisions on closer inspection.

3. There are areas where the siding should be repaired. The estimated cost is \$3,000.00.
