**DELAWARE TOWNSHIP**

**CAPITAL IMPROVEMENT PLAN**

Project No. 1228004

October 2013

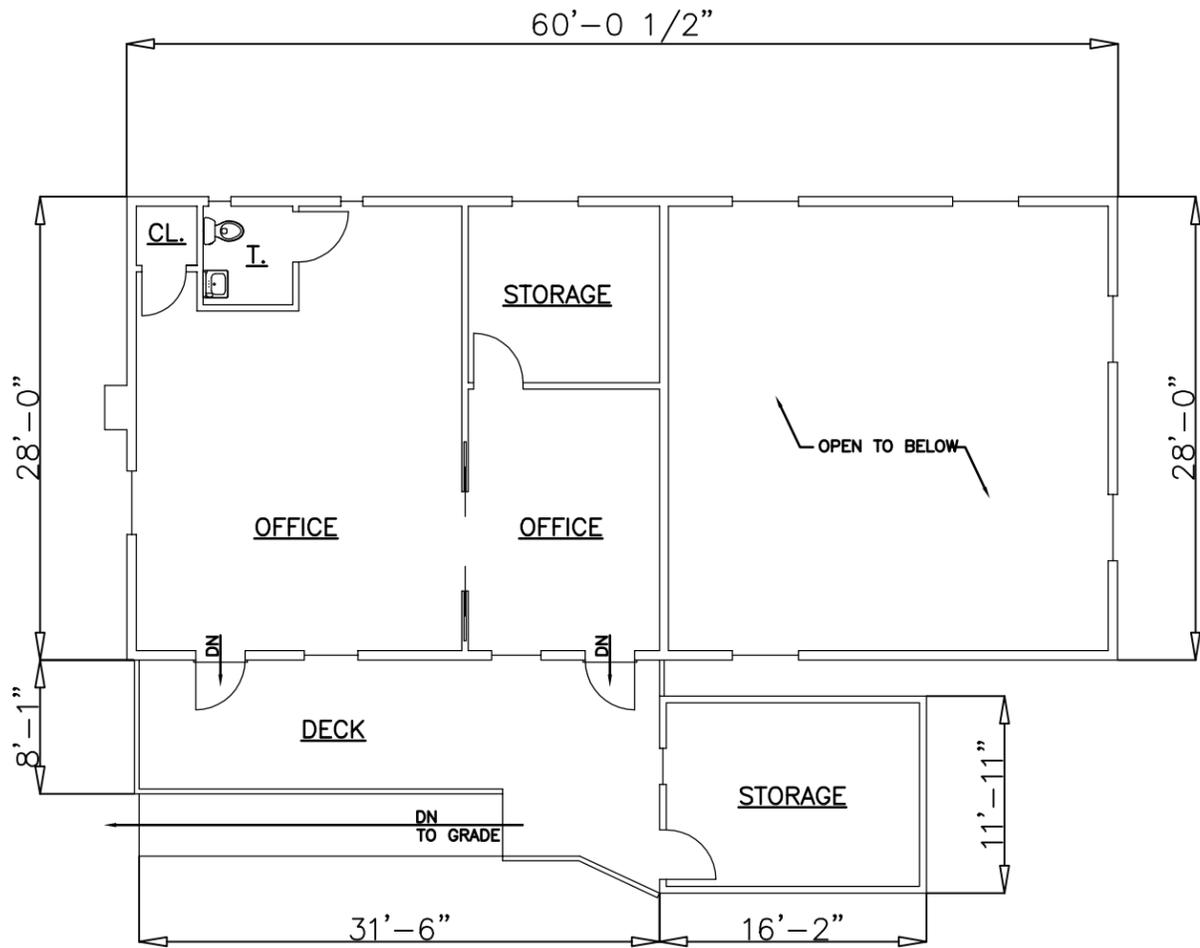
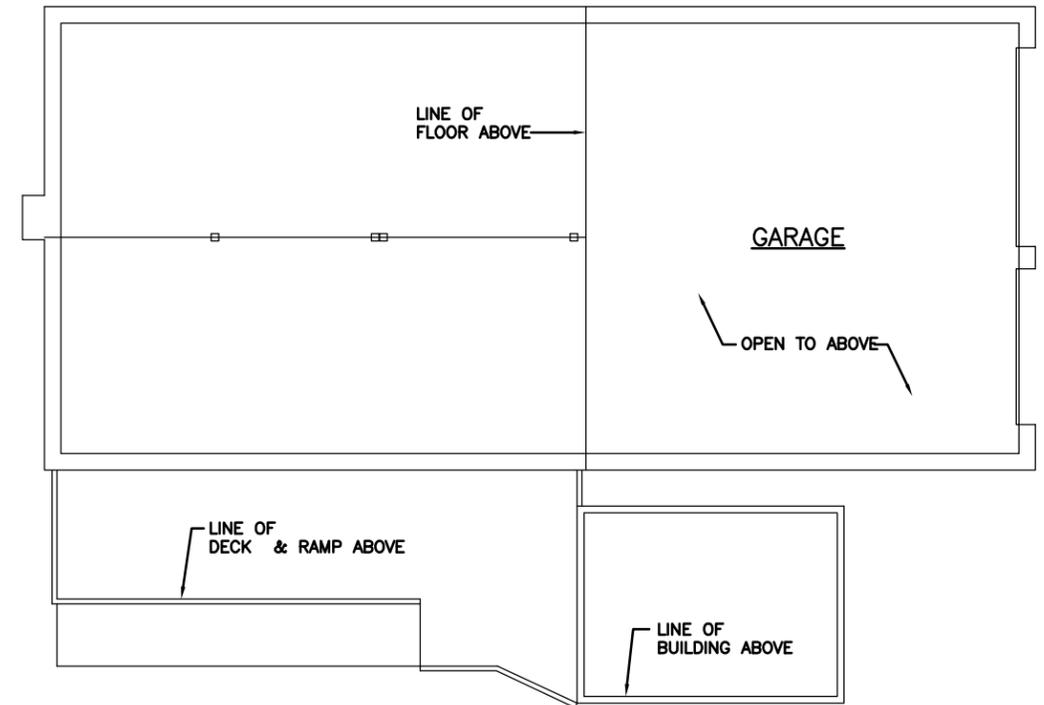
The ramp does not meet current ADA requirements. This could be upgraded for about \$5,000.00.

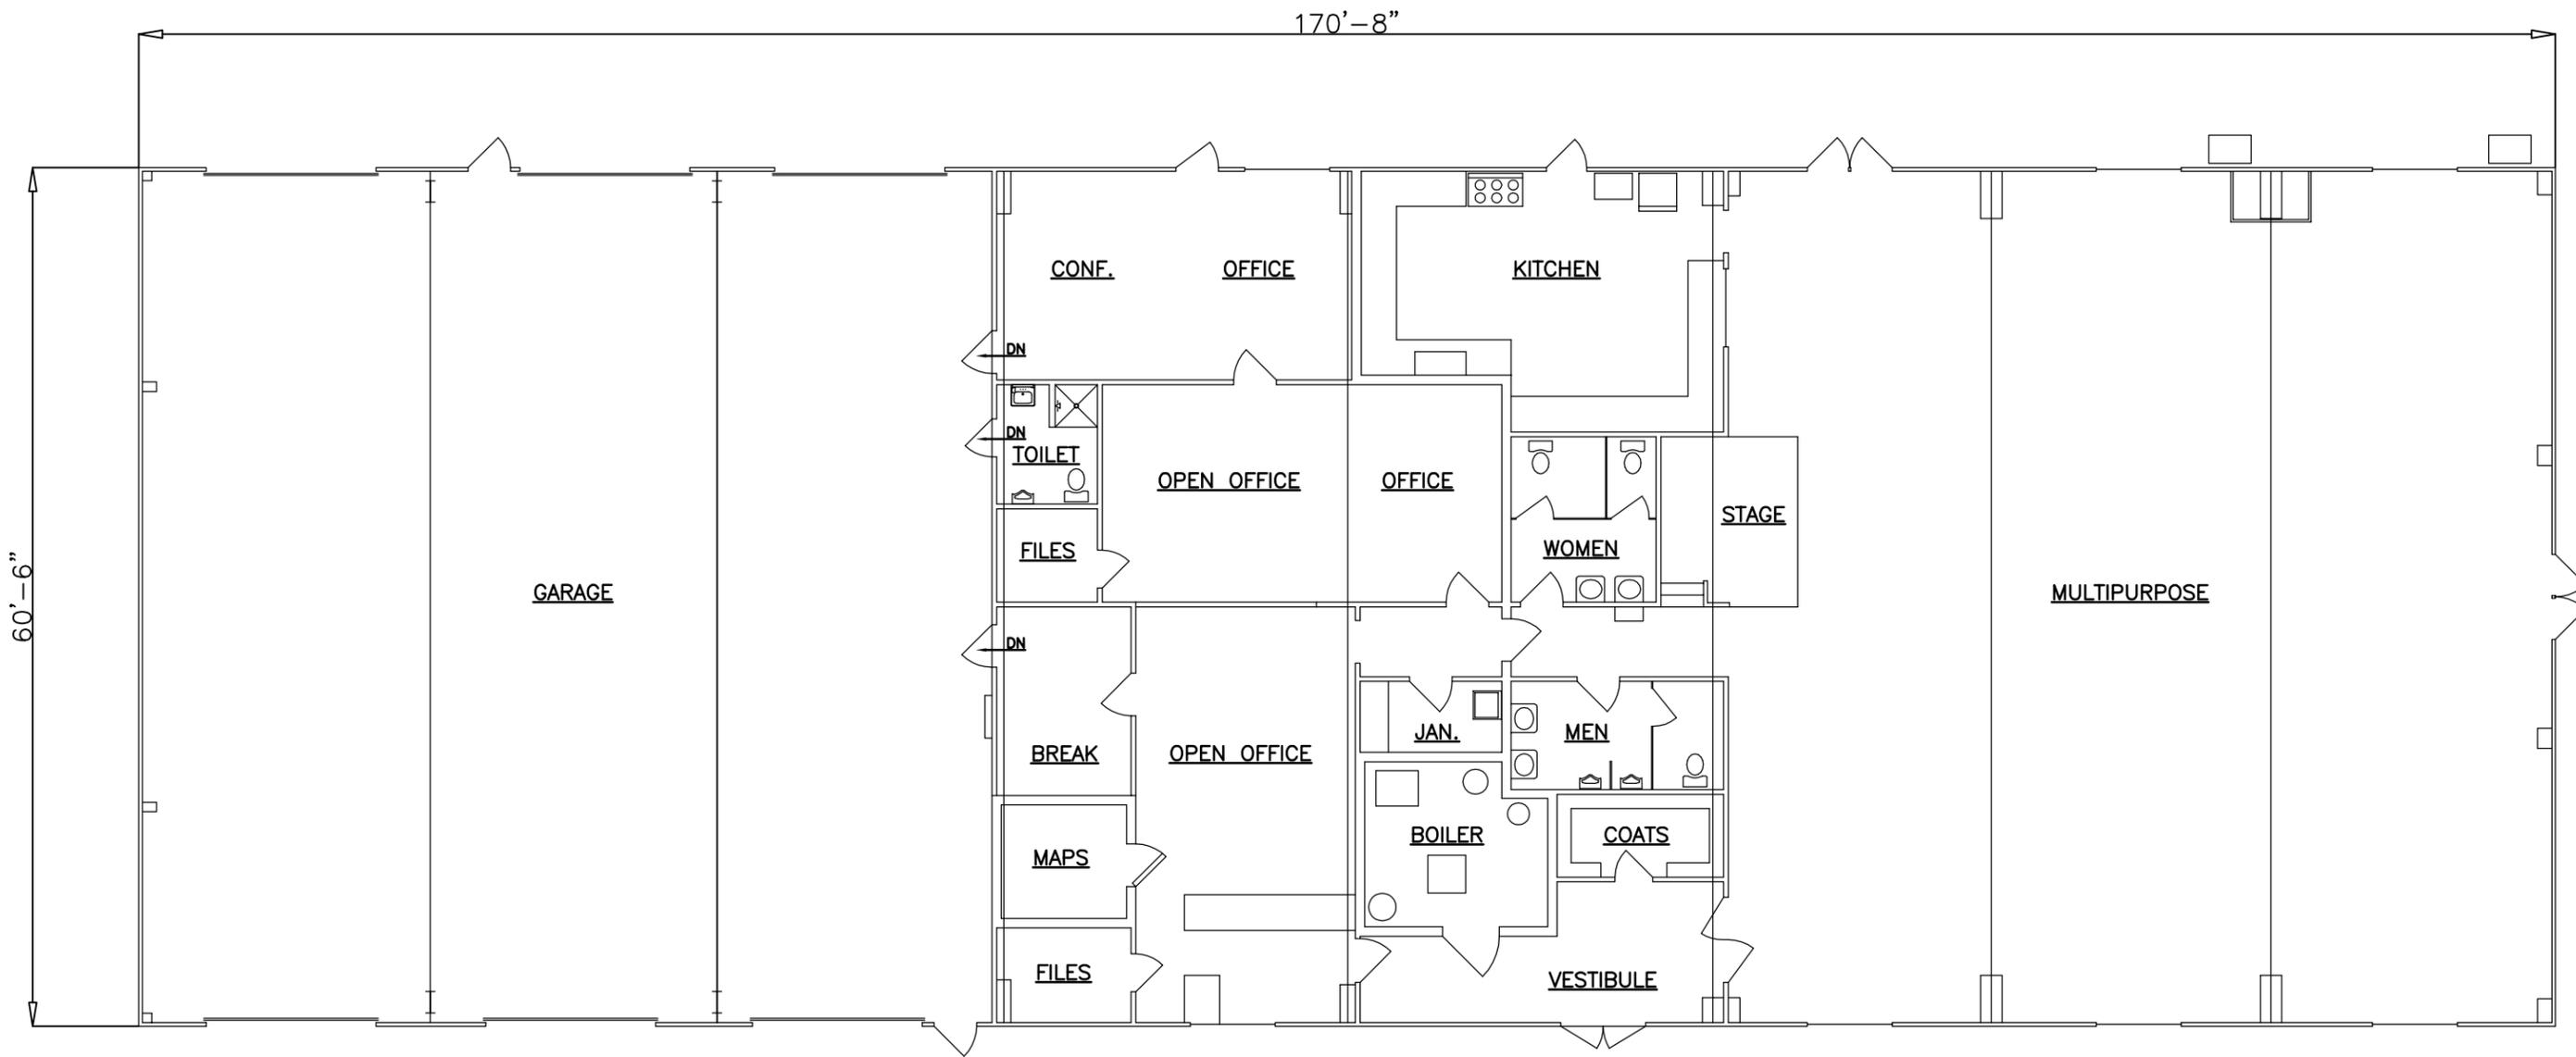
1. The building is in relatively good condition. It is approximately 33 years old.
2. In the multi-purpose room, it appears that there has been some movement in the slab on grade and it's around the perimeter of the building. Something has happened to make the floor move and it is visible.
3. The roof over the office and multi-purpose room appears to be in good condition even though it was applied in 1985-1986.
4. The floor in the garage could use a grout topping.
5. It is our understanding that the boiler was replaced in the Spring of 2013 . It is our understanding that the heating in the community room office does not appear to be adequate in the Winter. However, additional insulation was placed above the ceiling in the Winter of 2012/Spring 2013. We recommend the situation be evaluated after the room is in use through the next winter season.

1. While not necessary, the floor in the garage could be topped with a grout to seal cracks and indentations from spalled concrete. Estimated cost \$7,000.00.
2. We do not recommend the uneven floor in the community room be repaired. The cost to repair versus the added utility does not seem to be beneficial in our mind. However, if the Township wishes to repair, we would recommend removal of the existing floor covering, blending the uneven surfaces with an application of grout and reapplying a floor covering. Estimated cost \$15,000.00-\$20,000.00.

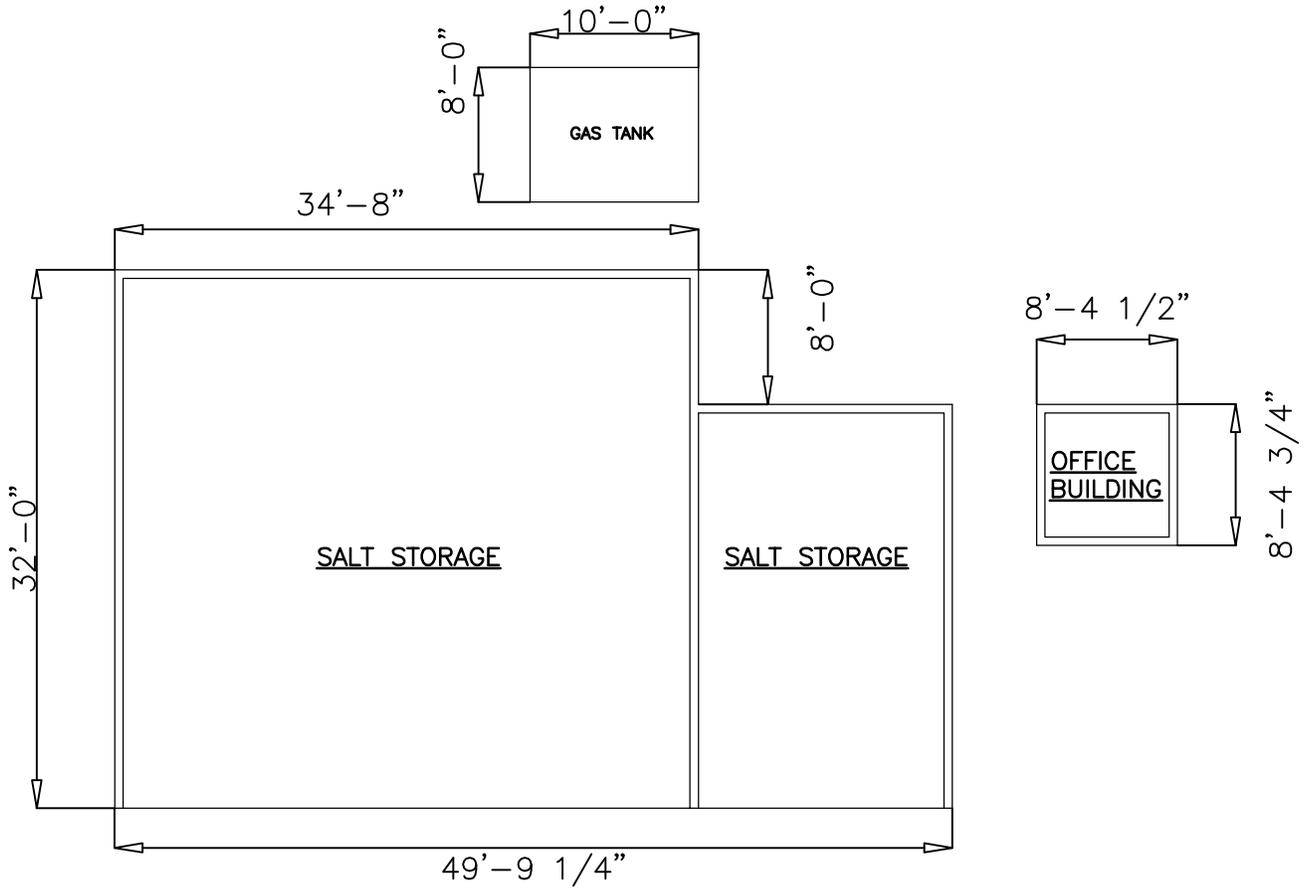
1. The building appears as if it is 15-20 years old. In some places in the building, the metal is rusting. Because of the salt and caustic conditions caused by the salt, the fasteners should be reviewed to determine whether or not they are structurally sound. If not, the whole structure could have new fasteners that are designed for caustic conditions.
2. Most of the floor was not observable because of the cinders and ashes on it, but it may be in a state of deterioration.

1. Repairs. The fasteners in the entire structure should be examined, tightened and/or replaced, if failing. We estimate this could be performed for \$15,000-\$20,000.00.
2. The Township may wish to consider replacing the existing facility with a new salt shed constructed of corrosive resistive materials. We estimate this could be done for approximately \$80,000.00.

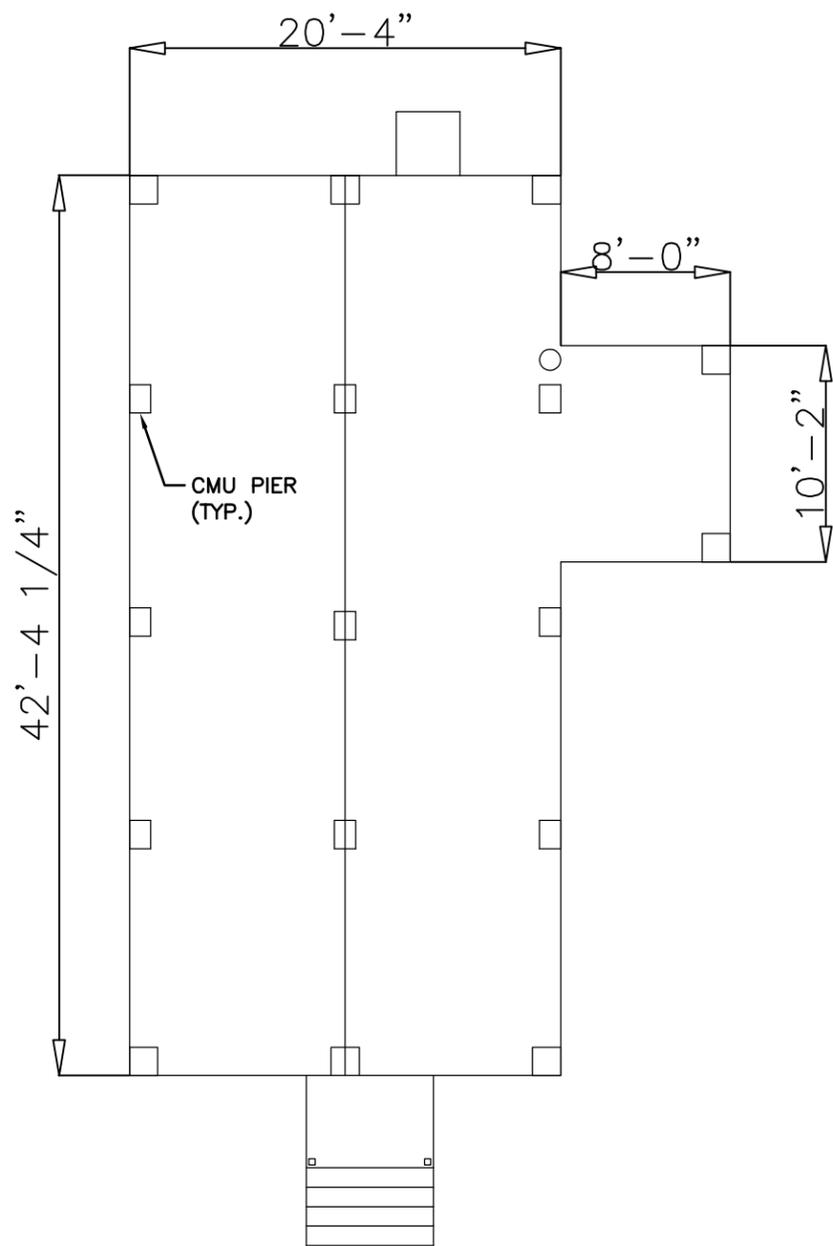
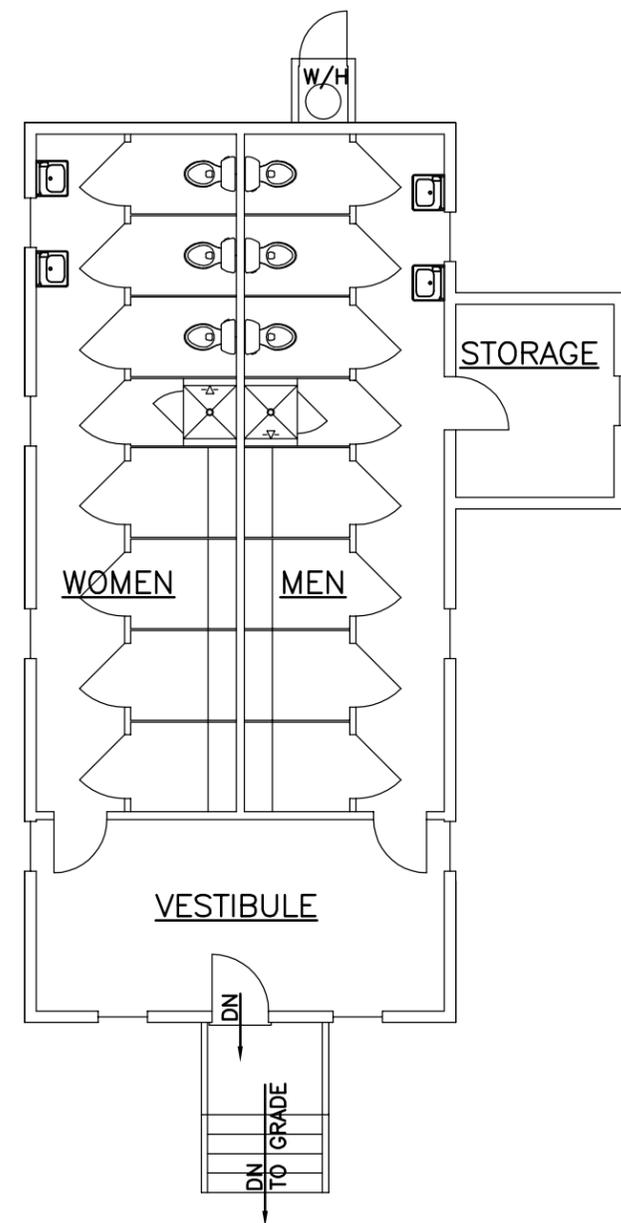
1. The building is supported by a number of concrete masonry unit piers. These piers do not appear to be below the frost level and some of the piers are leaning, cracked and so forth. The piers should be temporarily stabilized until a decision is made pertaining to the structure.

1. All aspects of this building are in need of repair. Repairing one item, for example does not alleviate the need for a more or less immediate repair to the roof. This is further compounded by the fact that it is not ADA compliant. We estimate the cost to completely refurbish the building and making it ADA compliant to be \$110,000.00. Even with this estimate it is difficult to estimate an accurate cost for the foundation (pier) repair.
2. A new building, ADA compliant is estimated to cost \$190,000.00.

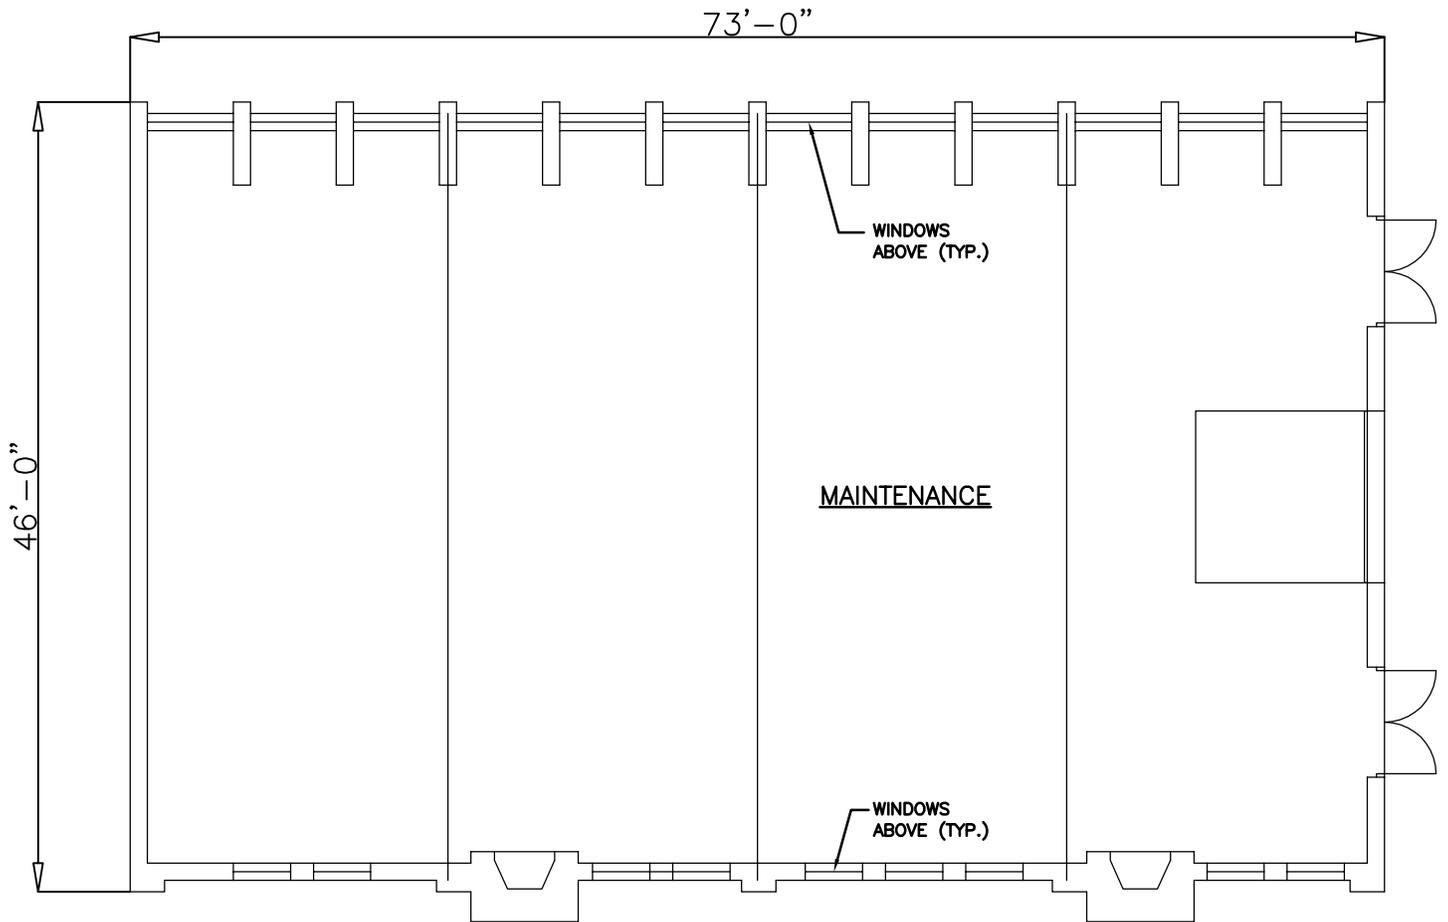
1. There are some minor cracks in some of the concrete masonry unit walls.
2. There appears to be some rainwater damage on some of the exterior concrete masonry unit walls and these should be repaired.
3. The gutters and downspouts should be reviewed to determine if they are large enough to handle the rainwater.
4. The masonry portion of the building appears to need a cleaning and it probably never had a water repellent treatment.
5. The building now has two means of egress, but they are not reasonably remote. Another exit door should be placed in the building to make the exits reasonably remote.
6. There is electric in the building, but there isn't any emergency lighting or no exit signs in the building.
7. The current building code would require toilet rooms.
8. A new rubber roof membrane with celotex underlayment with twenty (20) year warranty was applied in summer of 2013.

1. Calculate size of new rain gutters and downspouts and install. The estimated cost is \$6,000.00.
2. Patch cracks in foundation and masonry units. The estimated costs is \$3,000.00 to \$5,000.00.

3. Apply waterproofing to masonry walls. The estimated cost is \$5,000.00.
4. Provide emergency lighting. The estimated cost is \$3,000.00.
5. Provide another access door. The estimate cost is \$5,000.00.

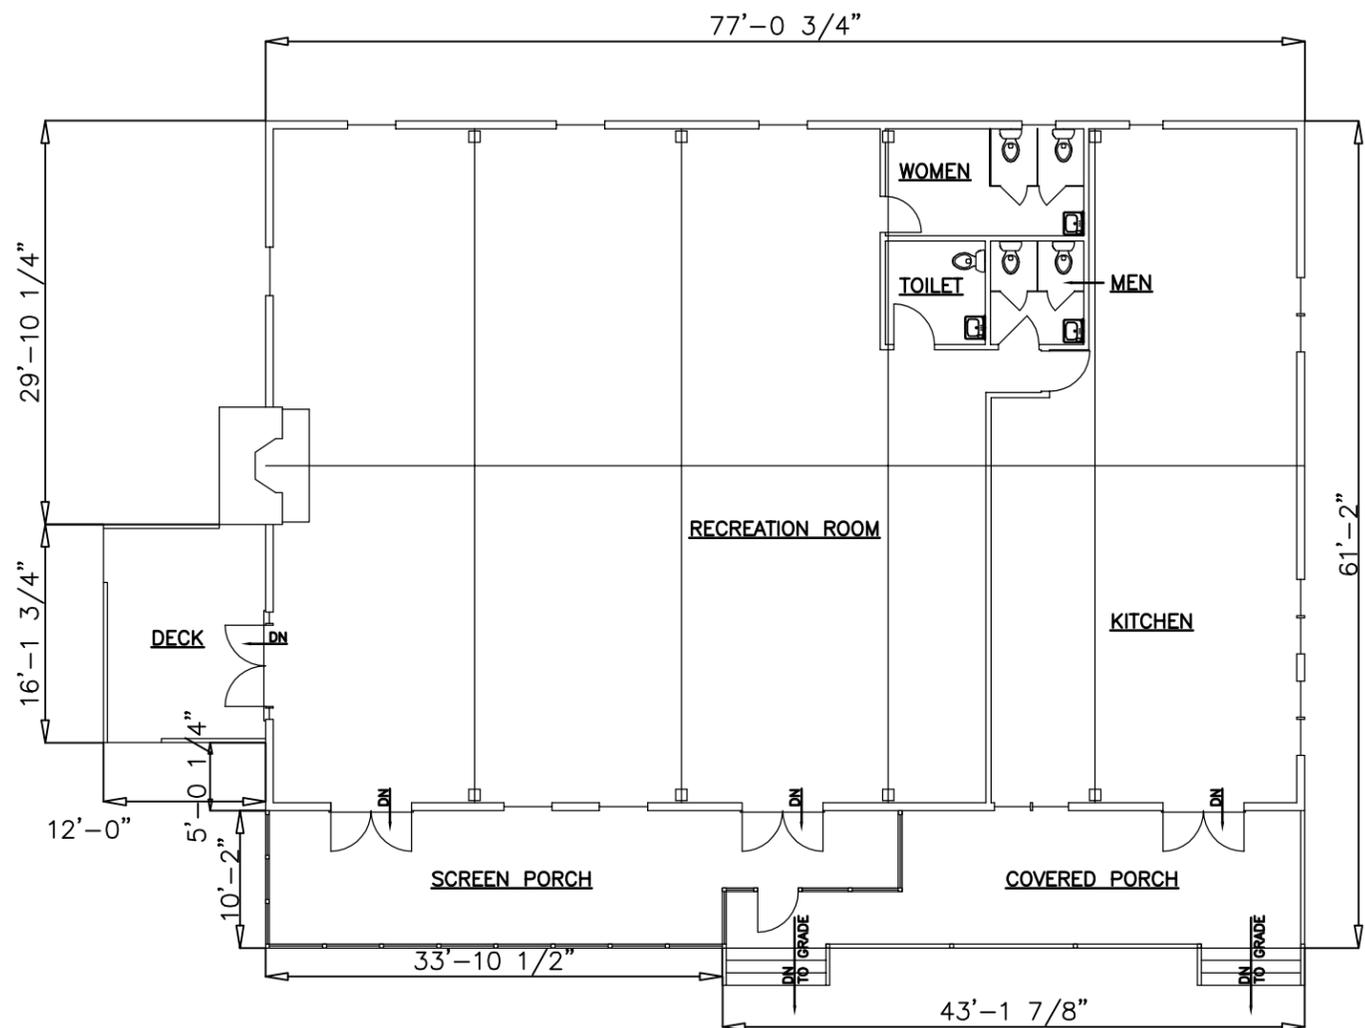
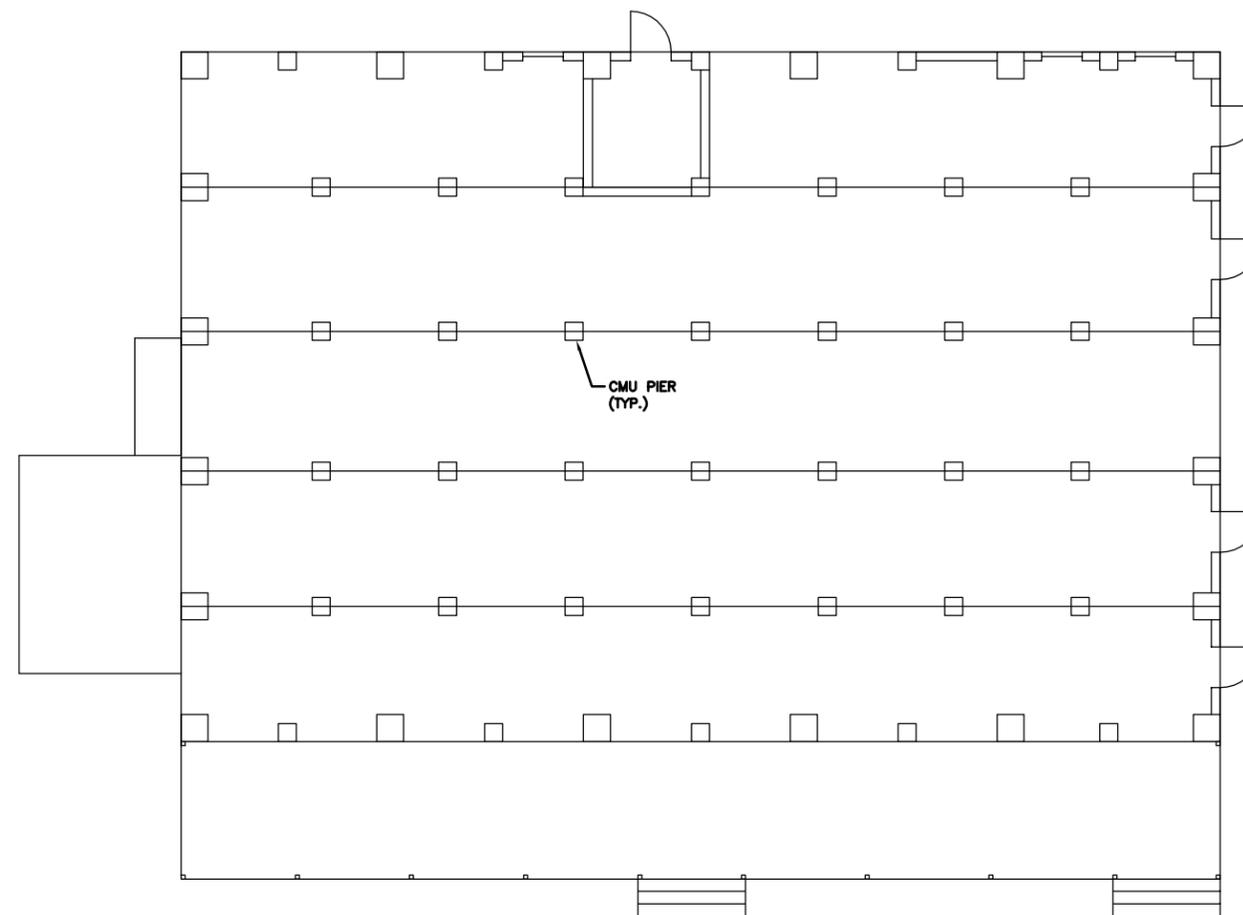
1. There is a grid of piers that support the building and it is questionable whether the piers go down to frost level.
2. The beams that support the floor joists are questionable. The floor joists themselves are marginally adequate. They are 2 x 8's at 16" on center and they are spanning 10 feet.

3. The floor structure and supporting foundation of the building should be analyzed to determine whether it is adequate.
4. The walls appear to be 2x4 wood construction with wood siding on the exterior and wood paneling on the interior.

7. The building appears to need another means of egress. The remoteness of the doors does not meet Code. It's a recommendation that another door be placed near the rear of the building.

As state previously, approximately 1/3 of the 66 piers are misaligned. It is not possible to determine if this is a result of frost heave or loading. The entire roof load is transmitted through trusses to columns setting on 12 piers on the perimeter. A structural analysis may find the piers inadequate to support the column loads. However, there is no visible leaning or racking of the overall structure which has been standing 50-60 plus years. If the piers supporting the columns are in fact sitting on rock, the support analysis could prove them adequate. The remainder of the piers offer support for the floor system, only.

The front porch is supported on a concrete slab with two large cracks and noticeable deflection.

1. To maintain the building under any scenario will require repairs to the supporting piers. During our initial observations we were unable to determine if they have frost protection. Due to the shifting of some of the piers we believe they do not. However, after careful consideration it may not be feasible to provide frost protection due to the difficulty of working beneath the existing structure. With that understanding, all piers should be thoroughly checked for plumb and structural integrity. Repairs are estimated to cost \$25,000.00, although this estimate is subject to revisions on closer inspection.

Considerable thought has been given to the foundation. Floor joists were analyzed and determined to be marginally adequate but okay. Stringers will have to be reinforced. We believe the best solution to repair and stabilize the foundation is to construct a perimeter foundation in place beneath the existing structure. The structural loads are transmitted to the ground via the column loadings on the outside piers. The perimeter foundation can be used to buttress these piers. Secondly, the enclosed foundation system will provide frost protection for the interior piers. There are 66 piers supporting the building. We estimate perhaps 20 should be rebuilt due to being out of plumb and/or of questionable supporting capacity.

The perimeter foundation should have a footer placed below frost level; in this region 48" below grade. Bedrock could be a problem during excavation. If solid rock is encountered, at less than 48", the foundation could be pinned into the rock. The foundation wall could be a combination of concrete and masonry block. For this estimate it will be assumed a footing can be placed 48" below grade and will extend out of the ground an average height of six feet to the underside of the framing (higher in the back, less in the front). Because of difficulty in working we estimate the cost will run \$500/cy of concrete.
